MSI GT72 2QE Dominator Pro CD Drive Replacement

Removing the CD drive from the MSI GT72 2QE Dominator Pro.

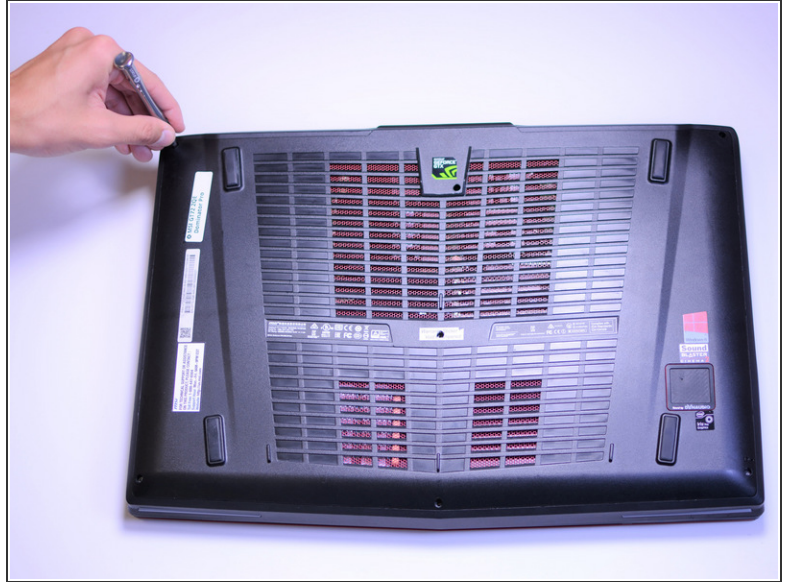
Step 1 — CD Drive

- Remove the indicated seven (7) 6 mm Phillips #0 screws for the back cover.

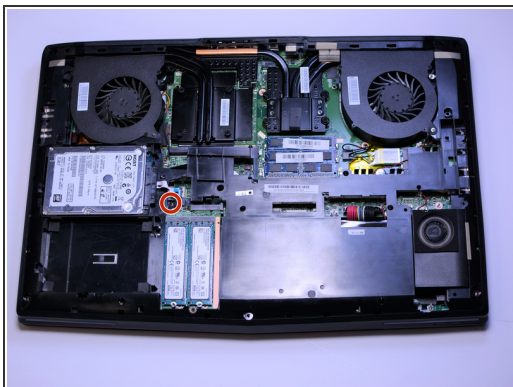
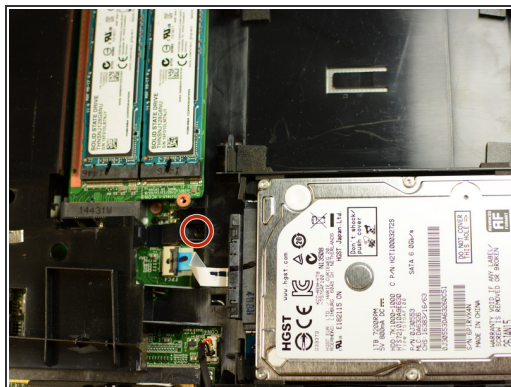
Step 3

- Remove the indicated 5mm Phillips #0 screw.

⚠ This is the only screw holding the CD drive in place. Do not lose it.

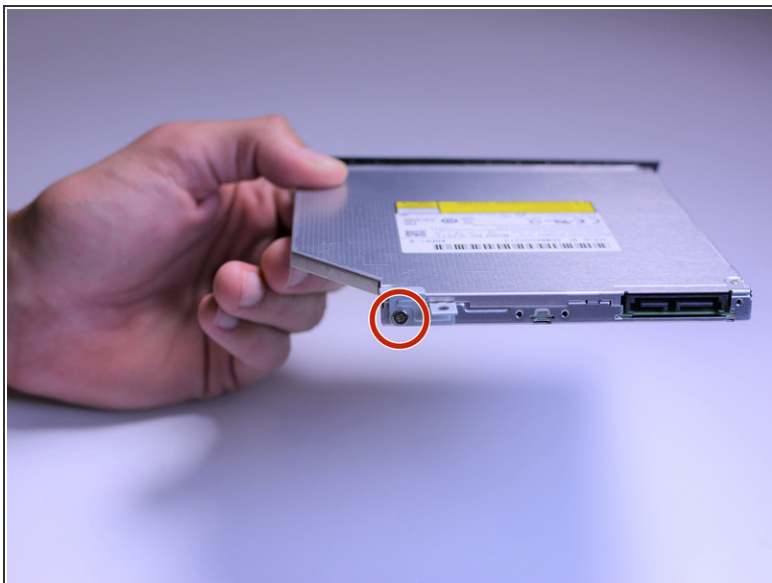
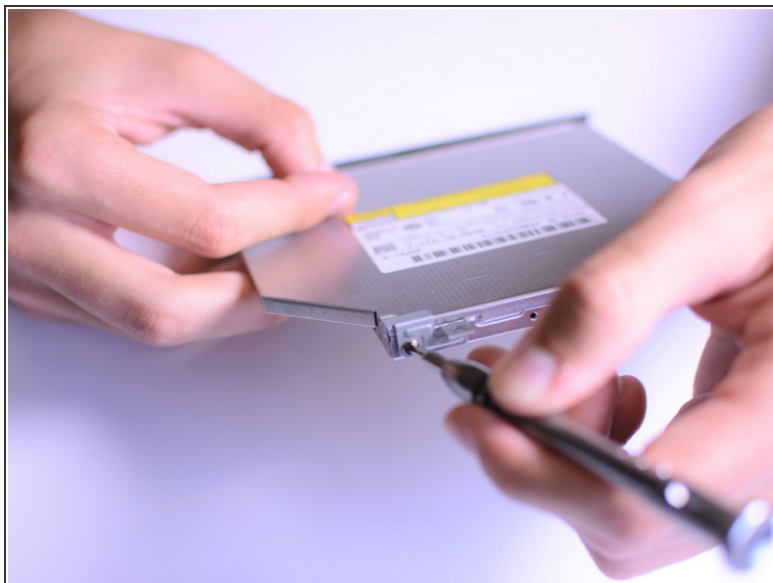
Step 5

- Remove the indicated 4mm Phillips #0 screw and metal hinge.

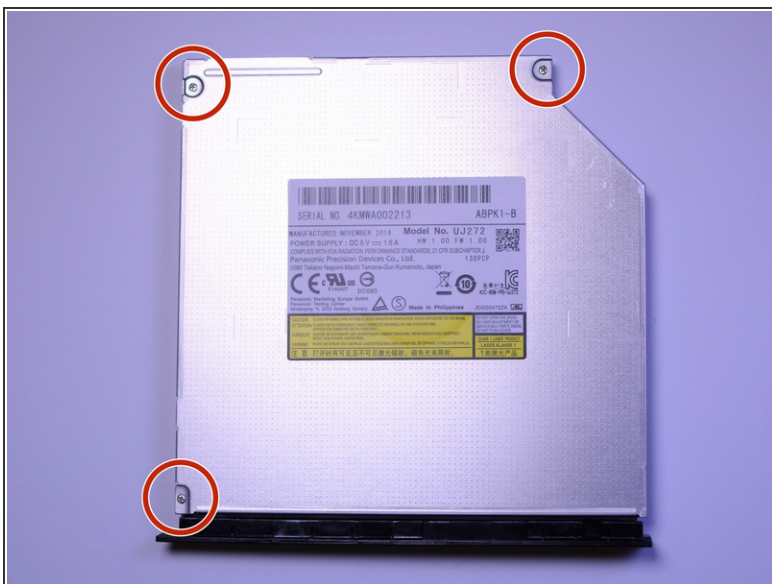
Step 6

- Remove the three (3) indicated 2mm Phillips #0 screws.

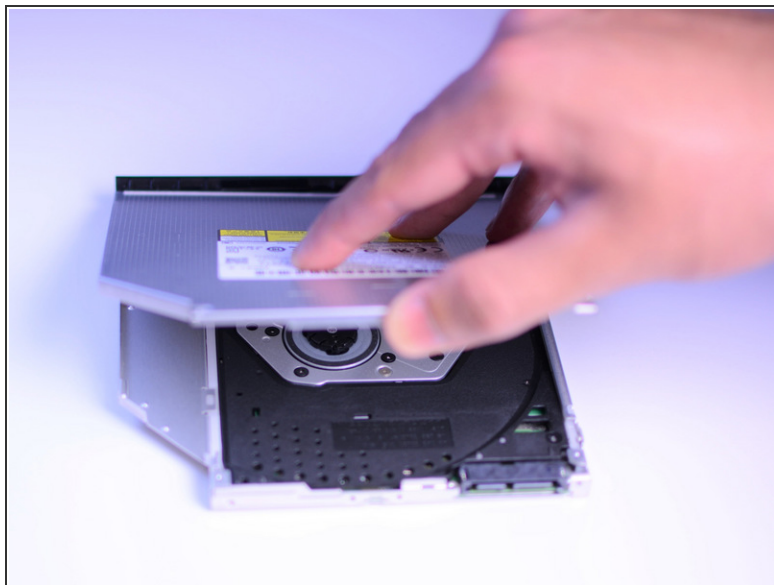
Step 7

- Lift metal cover gently, using the tab like indent located where the arrow is pointed.
- This should expose the inside of the CD drive.
